Great Saltpetre Cave Preserve Committee Meeting

February 9, 2017 – Jerry Brandenburg’s house

2017 Ticket House Project

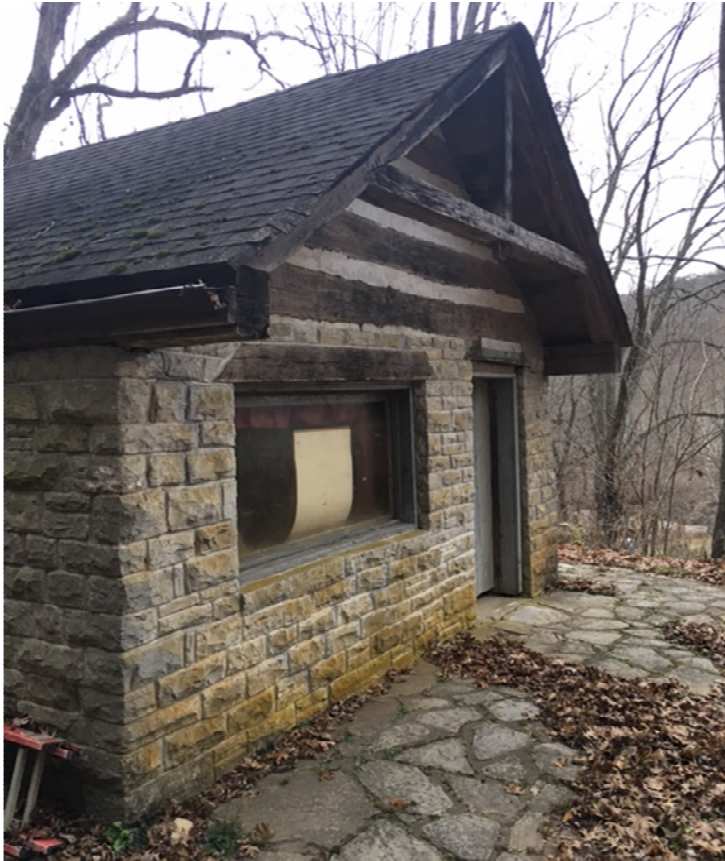
Front or West Wall

16'8" L By 7'10" (Stone) 13'8" Gable

8" Stone with wooden interior

1 Door 42" W by 78" H

1 Window 42" H by 72" L

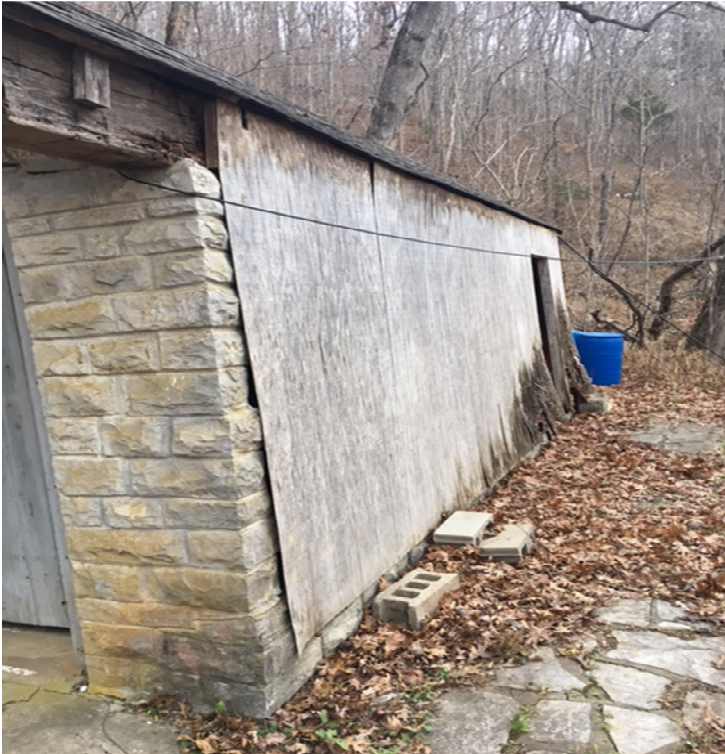
Downhill or South Wall

21'8" by 7'10" Multi veneer

Front or western part of the south wall
13'8" by 8" stone & interior of wood

Back or eastern part of the south wall
8" 8" stone & 8" Block

1 33" door 32" off the se corner

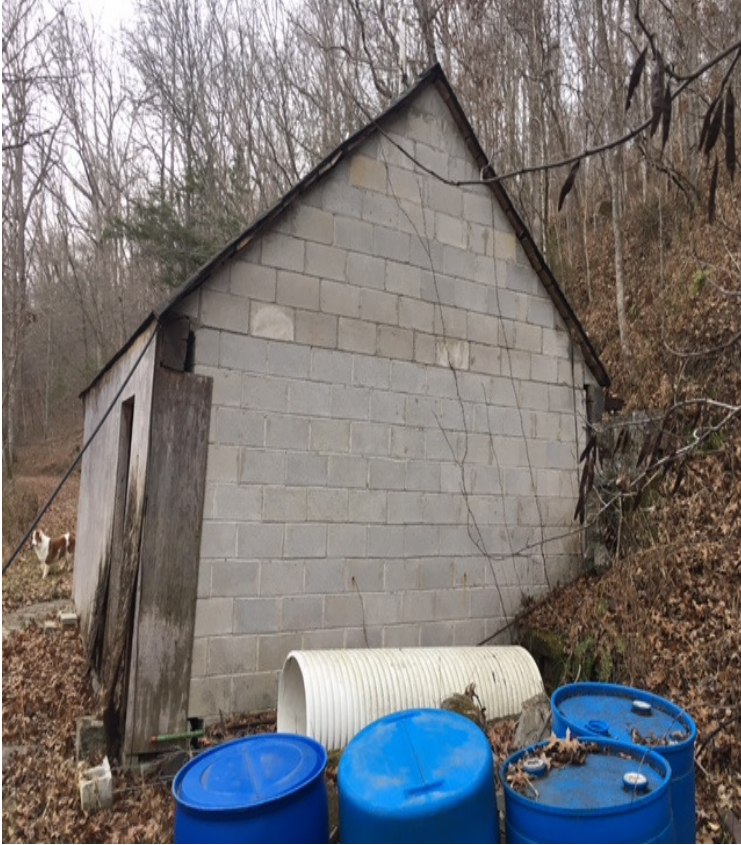
Back or East Wall

16'8" by 13'8" (Gable)

8" stone returns on the corners

15'4" 8" block in the center

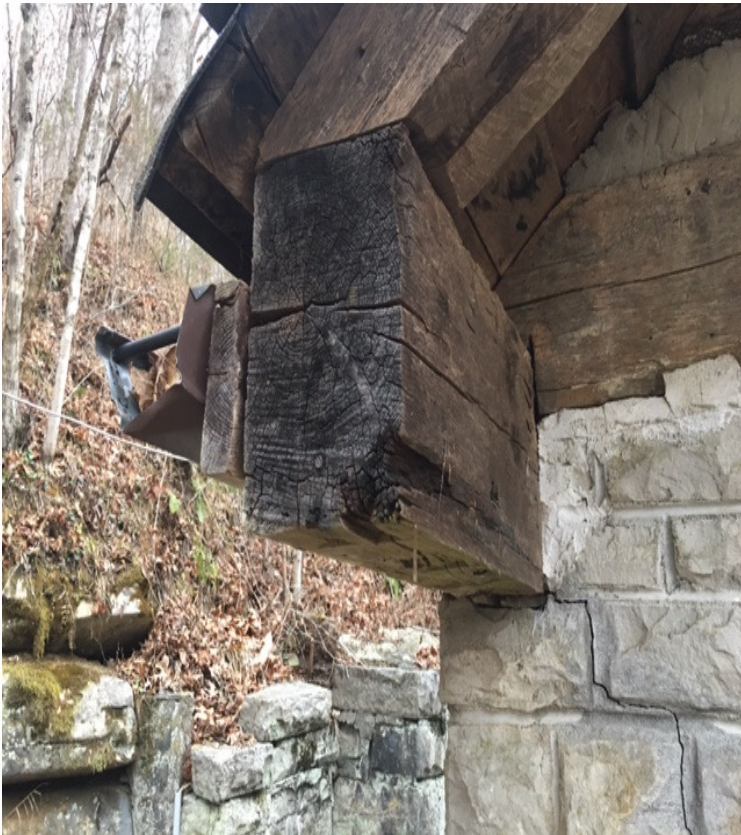
Twin Wooden Beams

Beams are 7" by 10" and run the length of the north and south walls and bear on the stone veneer.

North beam shows evidence of a stair step crack under the weight of the beam

The roof beams bear on the stone veneer. This is not normal construction practice. The roof load should bear on a structural wall (either concrete block or wood frame). Neena wants to look in the attic to understand the roof rafter/ceiling joist framing and connections to follow the load path from the roof down to the ground before the next meeting.

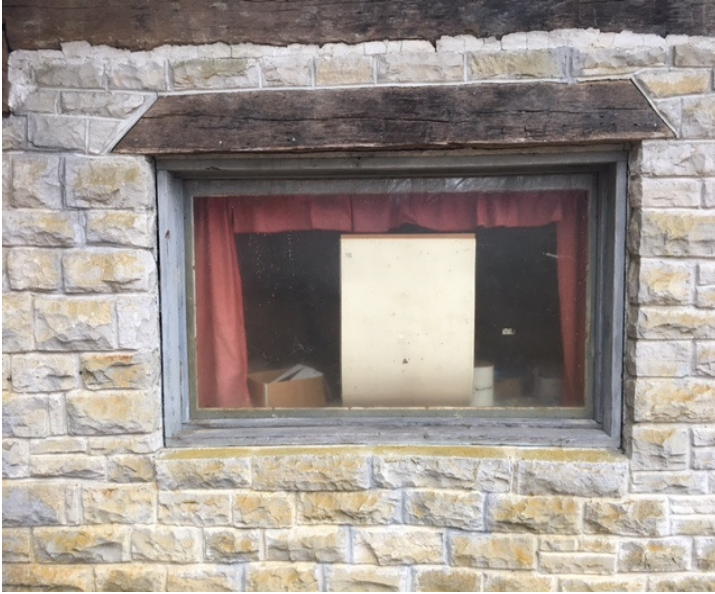
West Wall

Noticeable shift of the stone in the lower left corner of the window following the stair crack from the NW corner

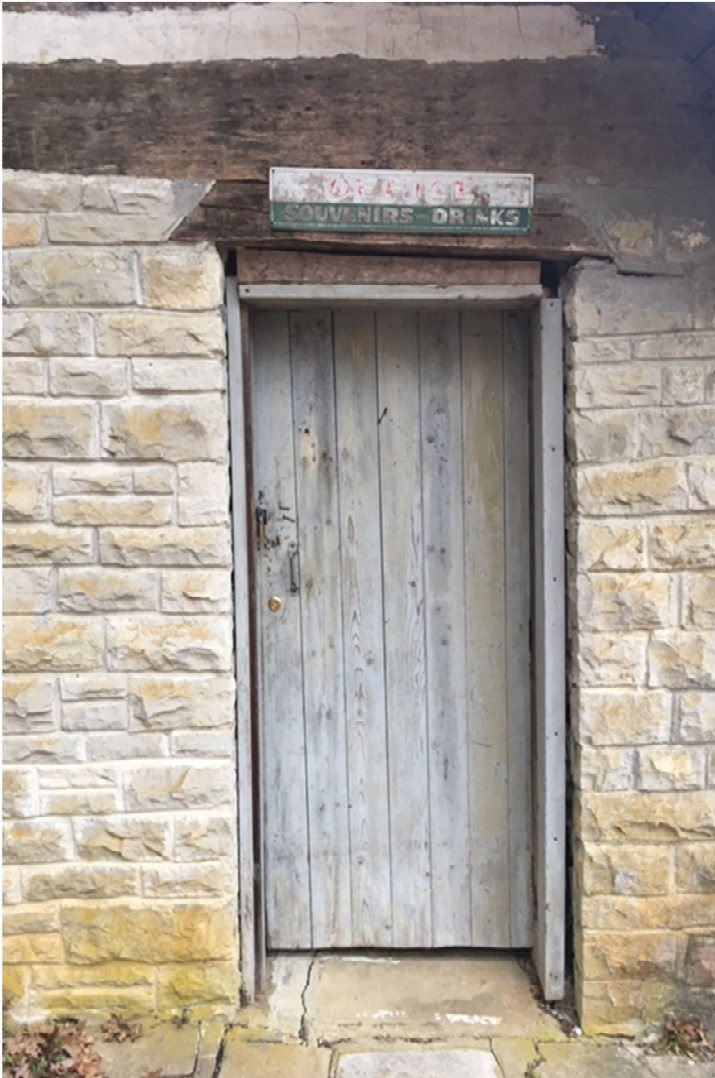
West Wall

Downhill shift in the doorway header

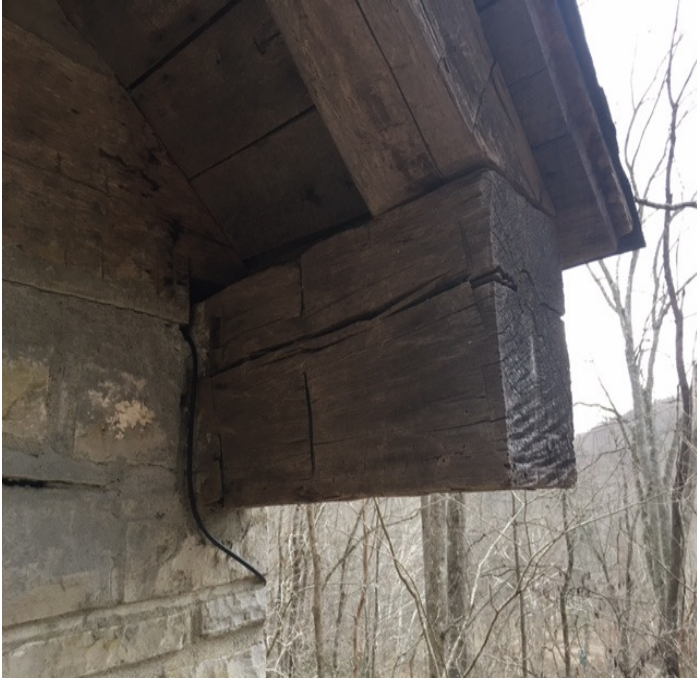
West wall

Southside beam resting on the stone veneer of the west wall showing a much greater evidence of sediment collapse.

Patch work is present

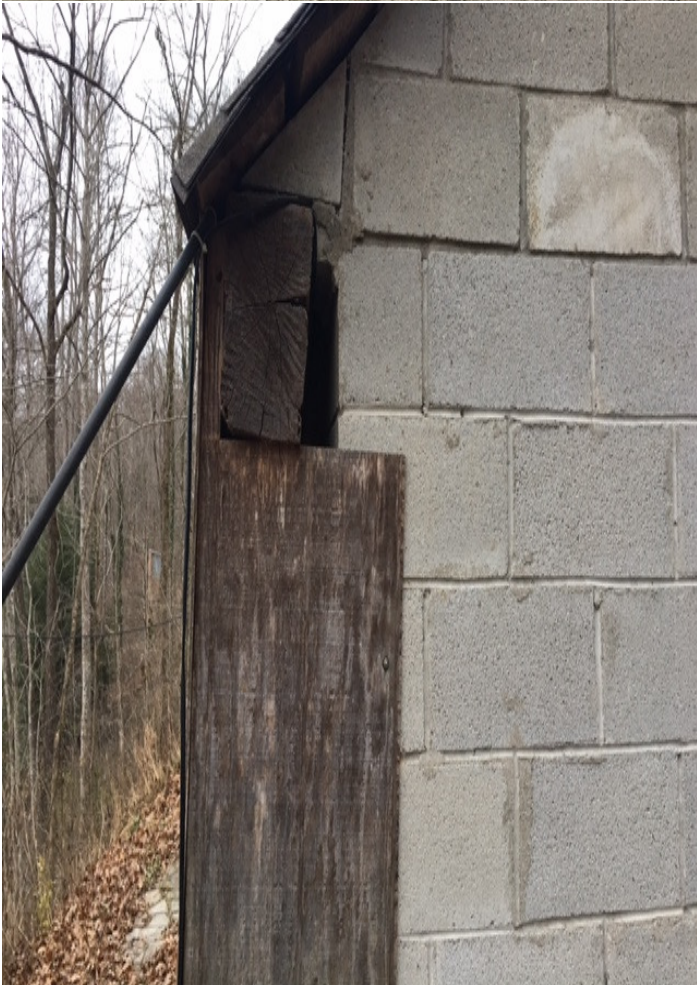
East wall

Stone veneer on south side wall is completely gone in the se corner. Beam is showing signs of the beam shifting downhill.

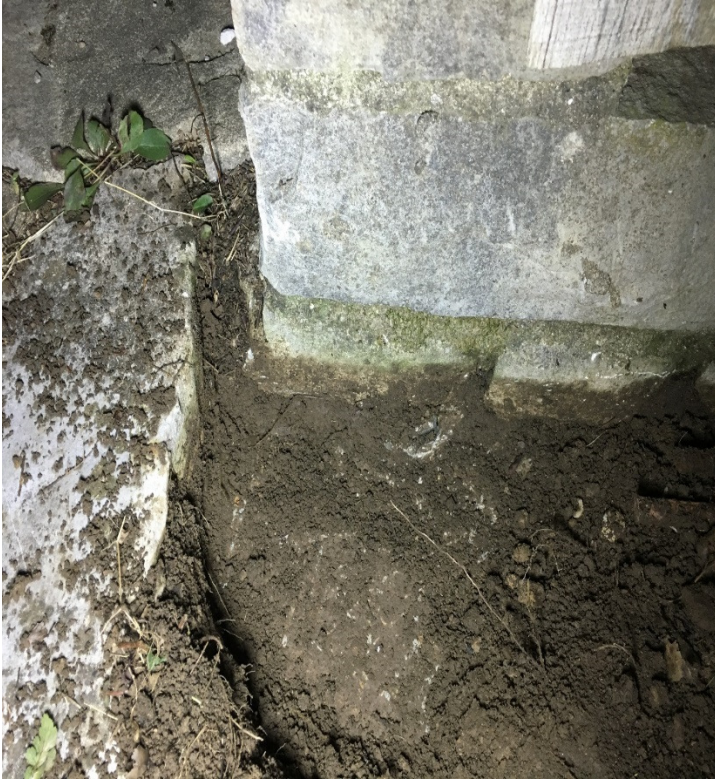
SW Corner

Exposing the foundation

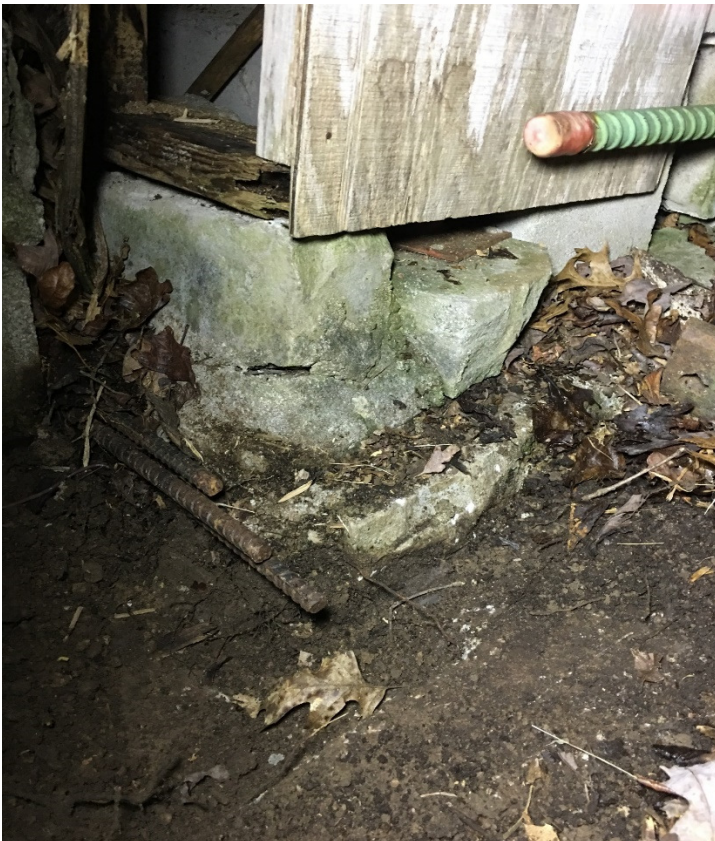
SE Corner

Exposed foundation

Stone veneer is present

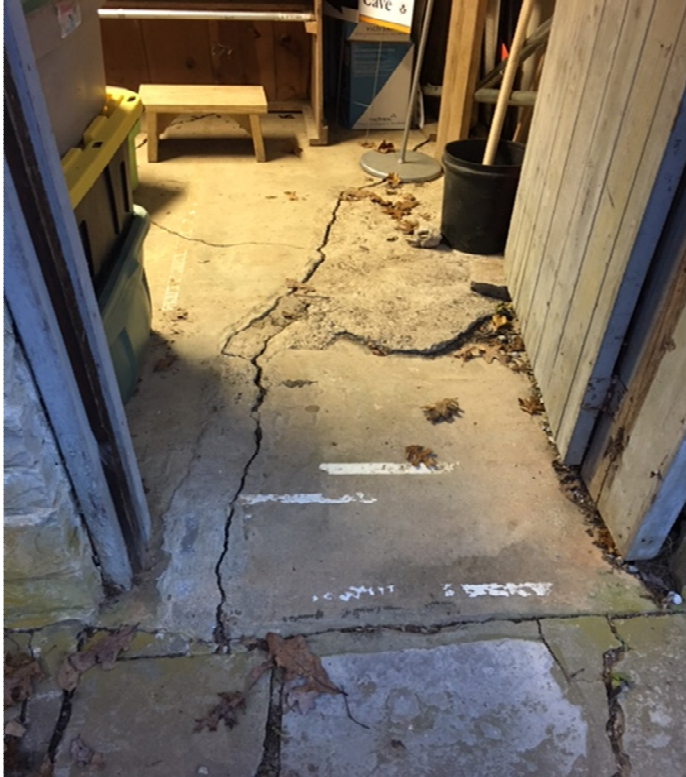
West Wall

Inside the door way of the west wall showing the beginning of the stress crack running the length of the south wall starting approx. 5' off the SW corner

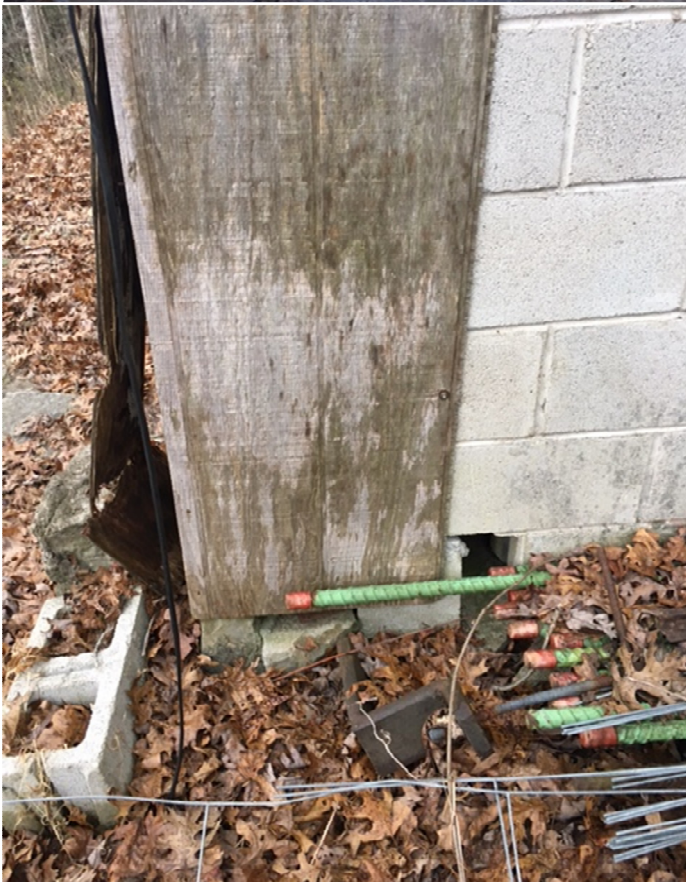
SE Corner

Stress crack exiting the back wall narrowing to approx. 2'.

Separation in the block wall is present.

Rebar and Durawall is shown and could be used in the repair.

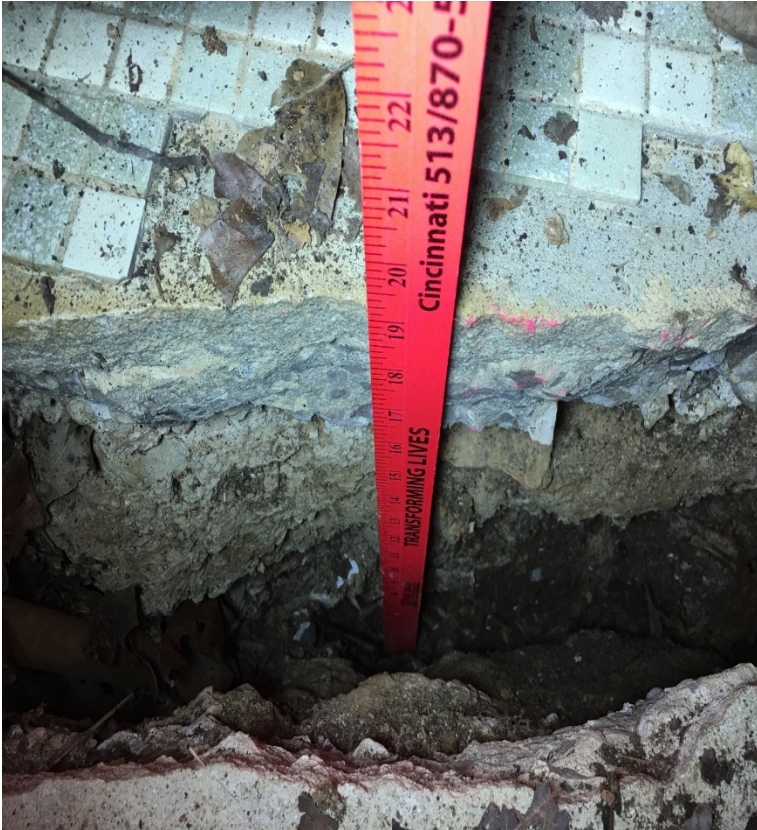
Room in SE Corner

The stress crack is at its greatest exiting the back wall. Crack is approx. 5" wide and 19" deep.

Concrete slab is shown to be approx. 4" thick without any reinforced rebar or Wire mesh.

Base layer seems to be loose soil instead of gravel.

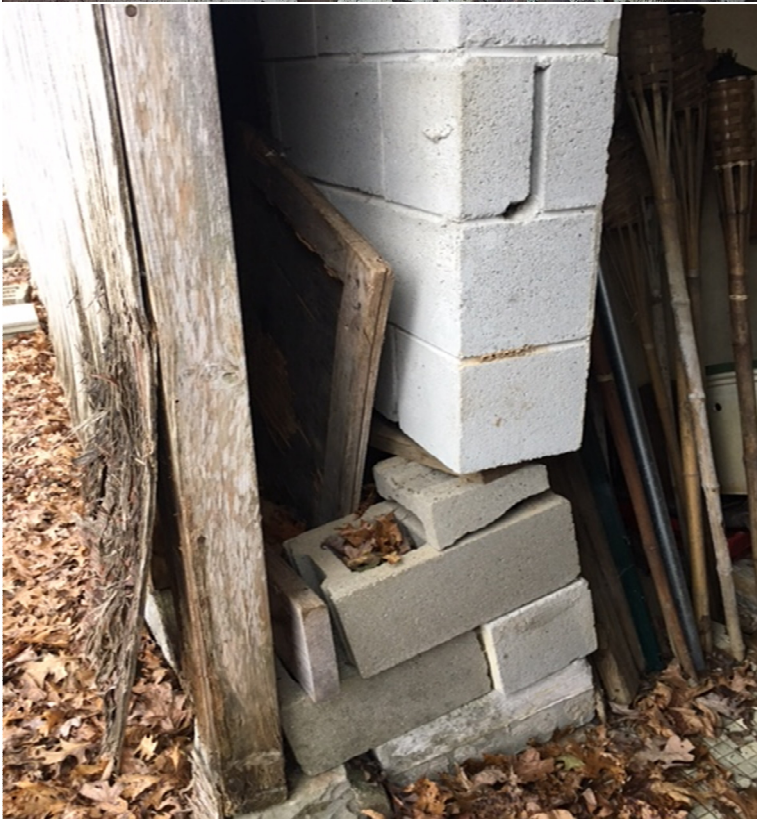
SW side of doorway on S wall

Results of the stress crack leading to block separation.

Evidence is present in the ground course but other than the return on SW corner no other stone is present

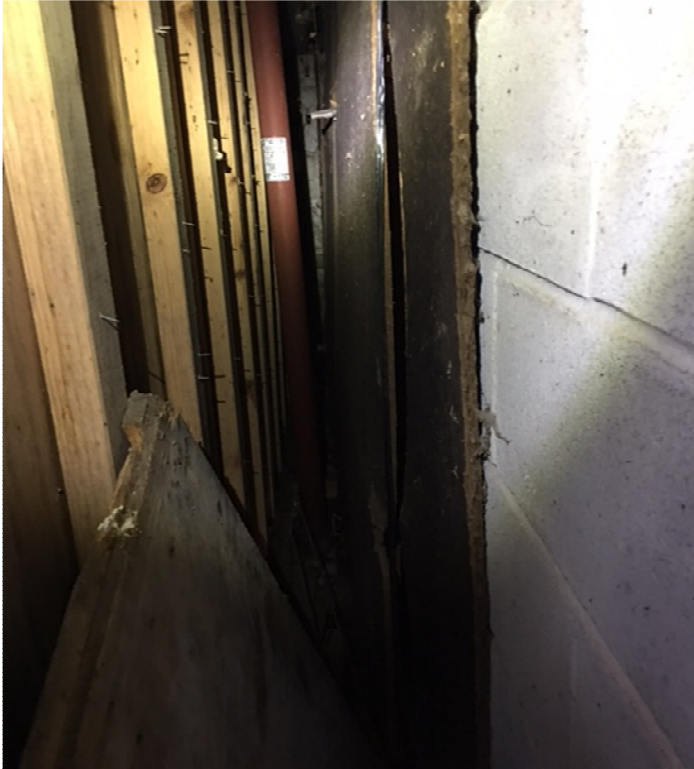
South Wall

Looking west showing beam support
and the division between block and
wood walls.

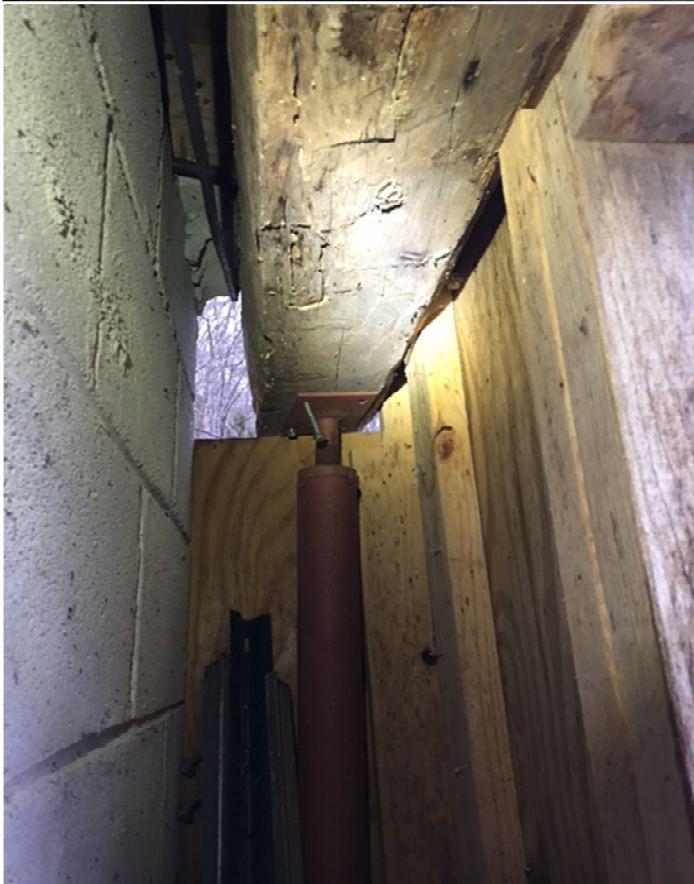
South Wall

Looking east showing the beam support
tilting away from building
